INTERNATIONAL INTERMEDIATE BULK CONTAINER FIRE TEST PROJECT

Scoping Tests

TECHNICAL REPORT

**Fire Testing of Intermediate Bulk Containers -
Failure Mechanism Tests**

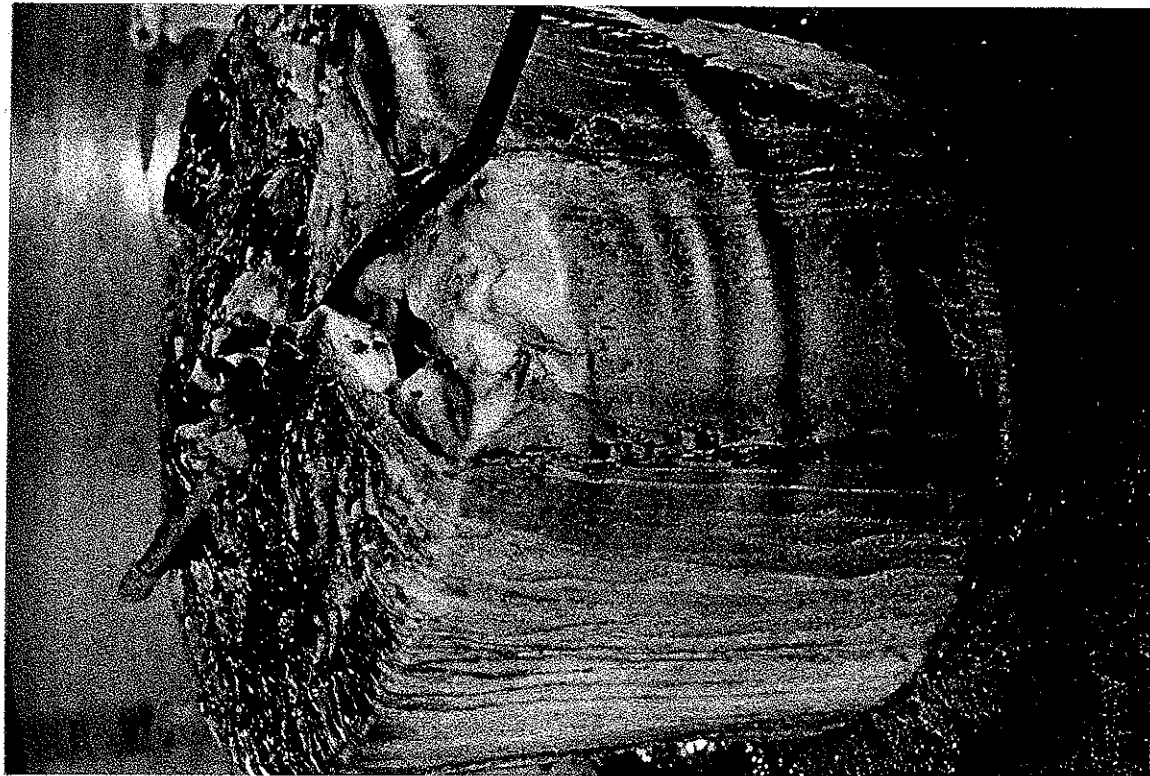
As the fire continued to burn, the ullage would soften (since there was no liquid heat sink in back of it) and ultimately collapse on top of the liquid. In many cases, liquid would start to pour out at the top, or a hole would be created at the liquid/ullage interface (Figure 9). In other cases, there was structural collapse, with the unit tipping over.

Figure 9 — Holing at liquid/ullage interface
(Unit 15, post-test)

The tests demonstrated that many units can survive a relatively long duration exposure without catastrophic discharge of liquid. Figure 9 shows Unit 15 after 21 minutes of fire exposure/burning. The unit was essentially in-tact, with a hole in the ullage.

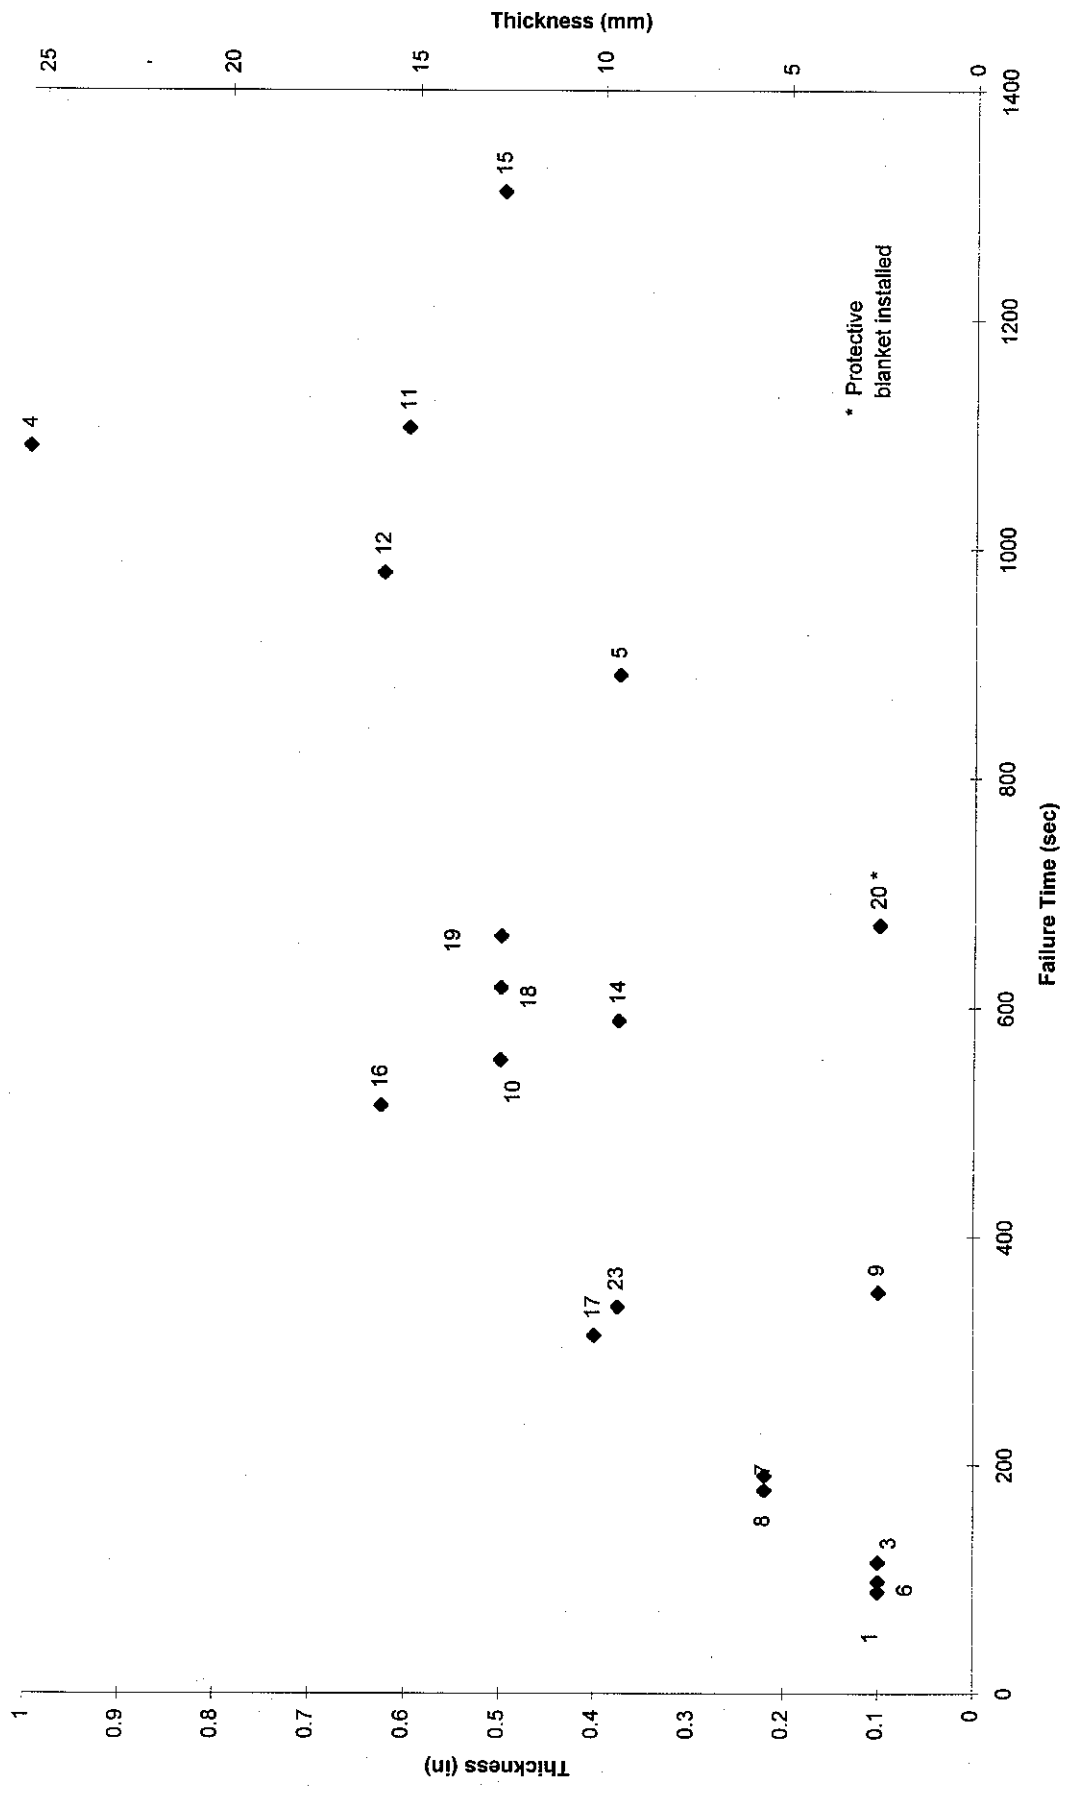
Failure can roughly be characterized as a function of container thickness as shown in Figure 10. This shows that there is a general increase in failure time with an increase in container thickness. Tests 13 and 22, where the RIM material was used, are excluded from the graphical analysis, along with the fiberboard unit (Test 21). This analysis does not distinguish between failure mechanisms (e.g., liquid breach vs. structural collapse). The "outliers" on the graph, Tests 9 and 20, indicate the improvement provided by a noncombustible shield (not included in the container "thickness").

Figure 10 - Comparison of container plastic thickness with failure time

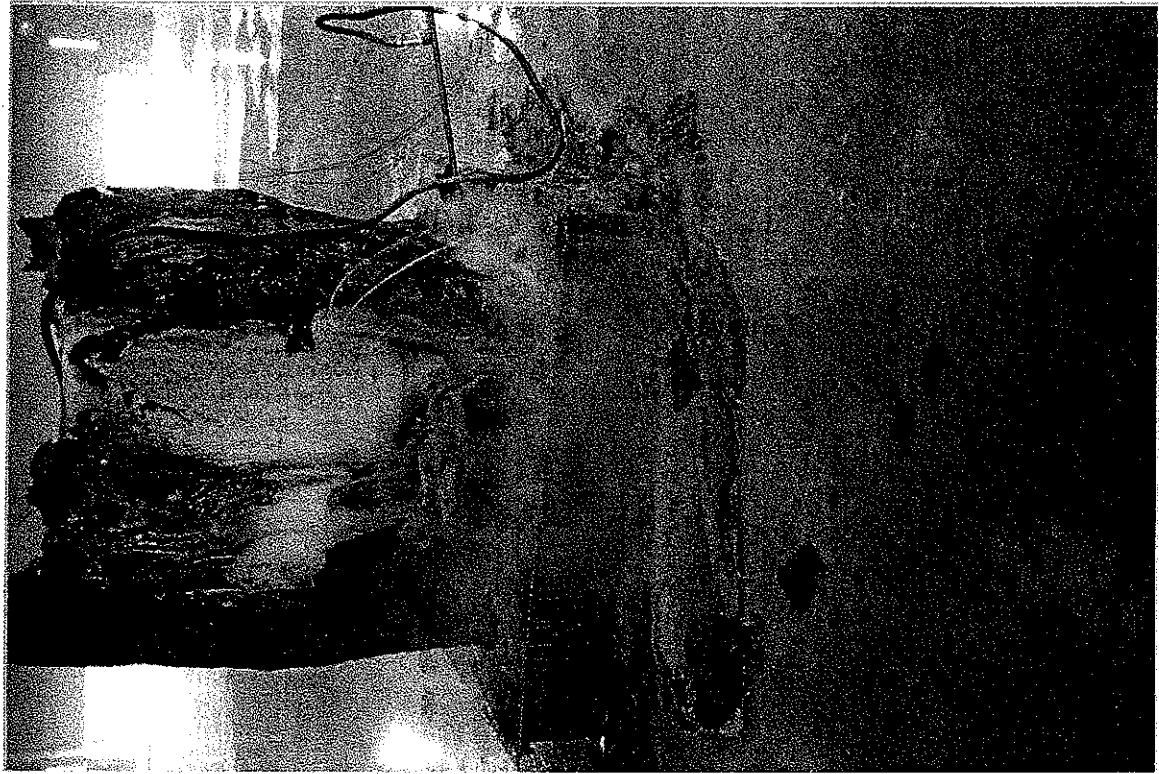
Figure 13 — Failure of IBC at viewing hole area
(Unit 4)

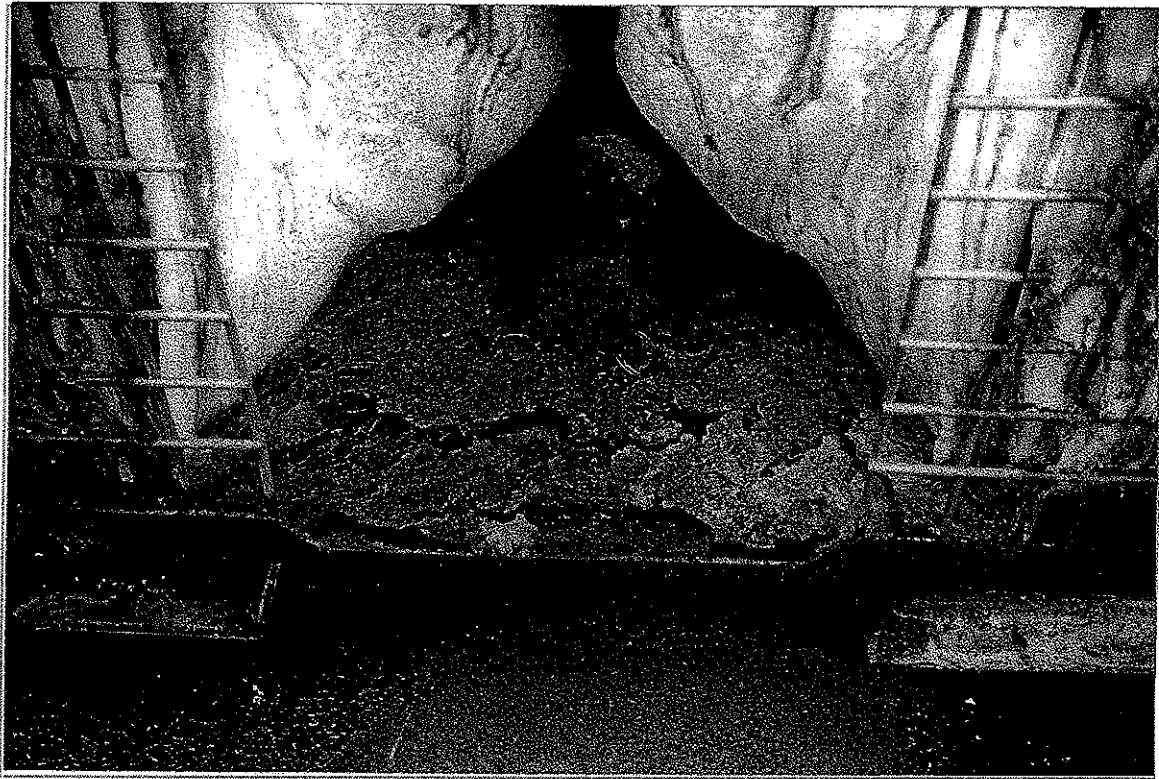
In the tests, failure in the valve area occurred only twice (Tests 5 and 9). In Test 5, failure in the liquid area and the valve area occurred concurrently, nearly 15 minutes into the test. In Test 9, liquid was leaking in the valve area but not in the valve itself. The leak occurred near the top of the doghouse, a high stress area. Figure 15 shows the result of the fire insult to a valve area which did not leak.

Figure 15 - Valve area damage with no failure (Unit 8)
